SUNRISE LAKE DAM

(NDI ID Number PA-00556  
DER ID Number 40-216),

PHASE I INSPECTION REPORT,

11 JULY 1979

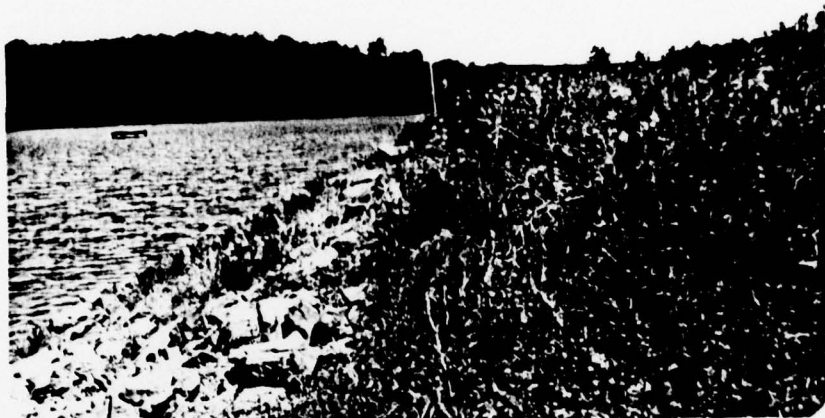
b. Embankment. The riprap on the upstream slope is generally in good condition (Photograph A), but riprap was missing at each side of the spillway. Crownvetch covers some areas of the riprap, and there were a few small shrubs on the upstream slope. The measured topwidth varied from 7 feet to 8.5 feet. The top of the dam and the downstream slope are covered with crownvetch about 30 inches high (Photograph B). The downstream slope appeared to be in good condition except along the right wall of the spillway chute, where there has been some surface erosion along a footpath (Photograph C). In this area, from the right wall of the spillway chute to the right abutment, the vegetal cover on the downstream slope is sparse (Photograph C). There are some large trees and brush growing just beyond the toe of the embankment to the left of the spillway (Overview and Photograph D).

A. Upstream Slope

- (1) Replace riprap missing at each side of spillway.
- (2) Replace headwall at conduit outlet with a structure that is structurally adequate.

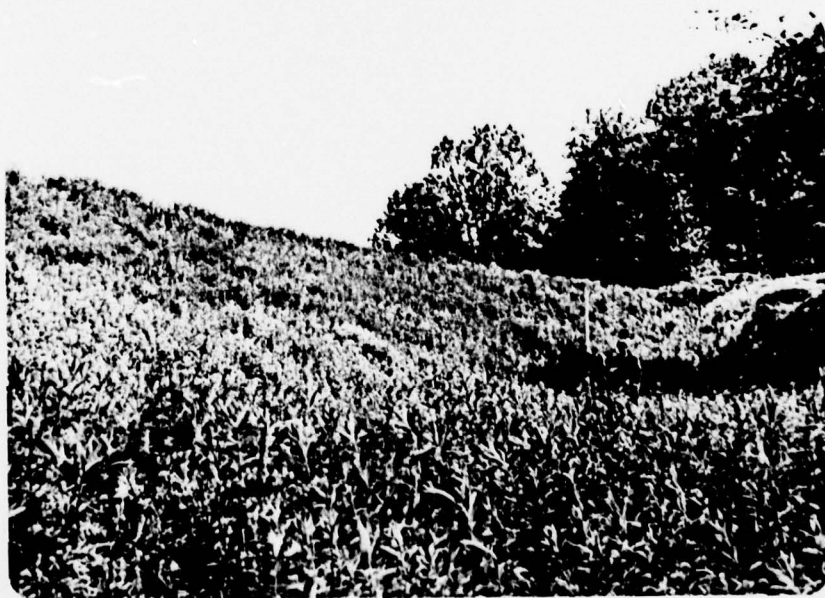
B. Downstream Slope and Left Abutment.

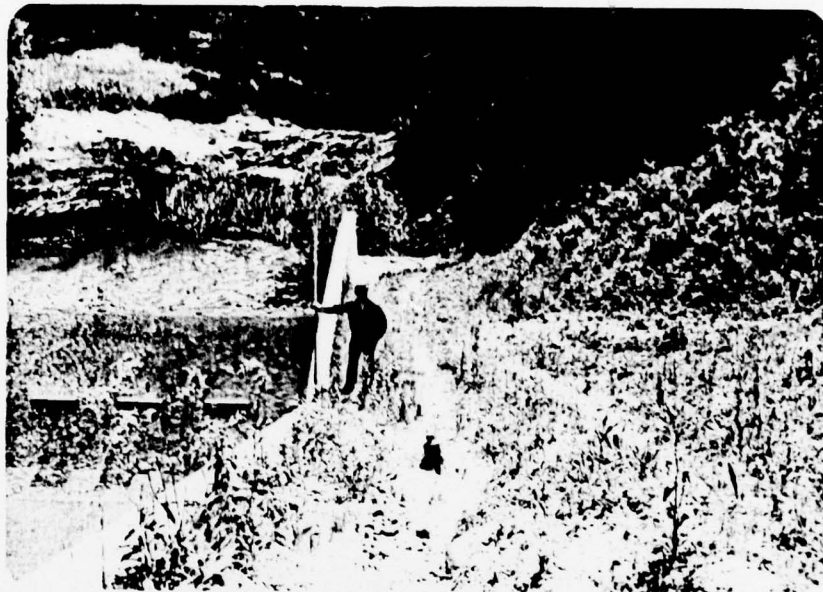
(2) Embankment. Riprap missing at each side of the spillway is an erosion hazard. The sparse vegetal cover on the downstream slope to the right of the spillway is inadequate and creates a potential for surface erosion. Where pedestrian traffic has been frequent, substantial surface erosion has already occurred. The brush on the upstream slope and the trees and brush that are at the downstream toe are undesirable. Although no signs of sloughing or embankment instability were evident at the time of the visual inspection, the downstream slope, which averages 1V on 1.7H, is considered to be too steep without stability computations to show that there is an adequate factor of safety. The design slopes and slope stability computations were not available for the Phase I Inspection Report.

C. Downstream Slope and Right Spillway Wall.

(4) Repair eroded areas on surface of downstream slope and establish adequate vegetal cover at all areas.

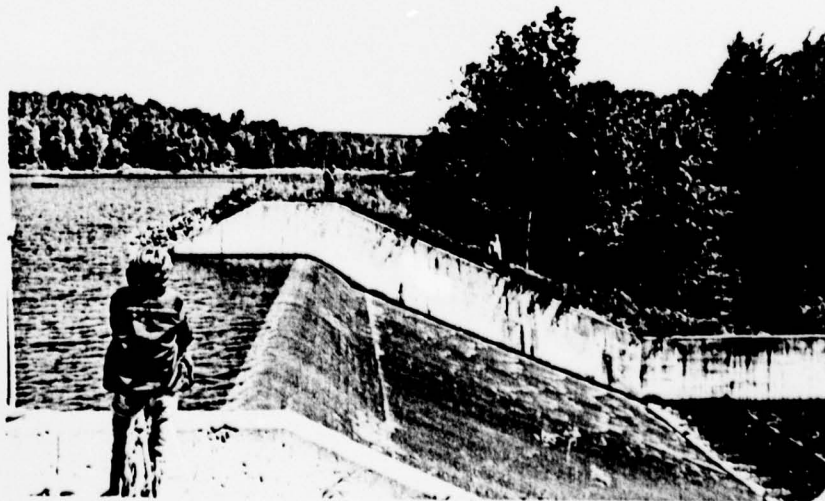
The spillway weir, chute, and stilling basin appeared to be in generally good condition (Photographs D, F, and G). The weir had some minor surface scaling (Photograph F), and the right chute wall was cracked at its downstream end. Some of the expansion joint filler in the chute was deteriorated slightly. There were stones and minor amounts of debris in the apron area of the stilling basin (Photograph F). Downstream from the end sill of the stilling basin, the channel bottom and side-slopes are protected by grouted stone riprap (Photograph G and H). Some of this protection had local areas of deterioration, which allowed water to enter at one point and exit farther downstream. A grouted stone obstruction about 4 feet high is located about 60 feet downstream from the stilling basin (Photograph H). Its purpose appeared to be for tailwater control in the stilling basin.

D. Embankment and Spillway.

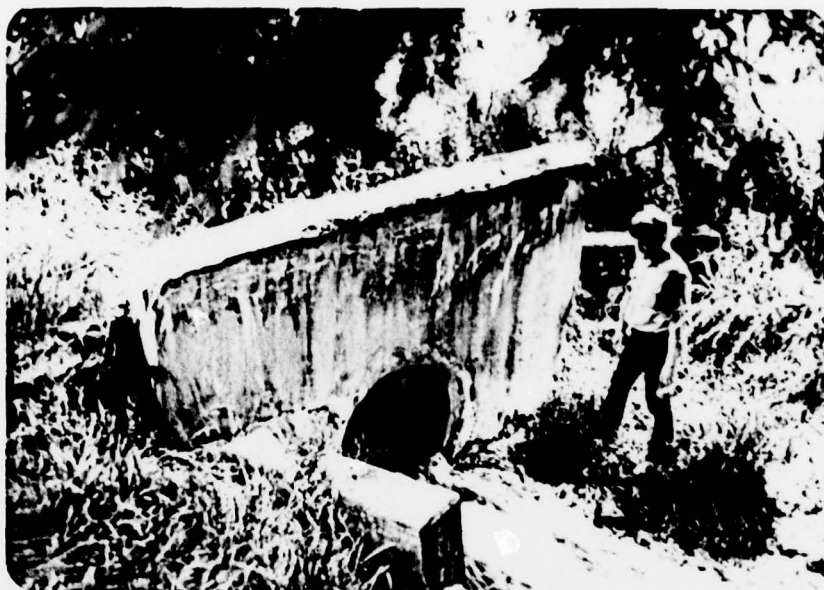
(3) Appurtenant Structures. The bridge deck leading to the gate mechanism should be maintained in good condition to provide safe access. The leakage at the slide gate is not considered to be serious at the present time. The deteriorating and tilting headwall at the conduit outlet is considered to be a hazard. Failure of this wall could cause blockage of the conduit or erosion damage to the embankment.

(3) Appurtenant Structures. The tilting of the concrete headwall at the conduit outlet is a stability problem. As noted in Section 5, failure of this headwall could create a serious condition.

E. Headwall at Conduit Outlet.

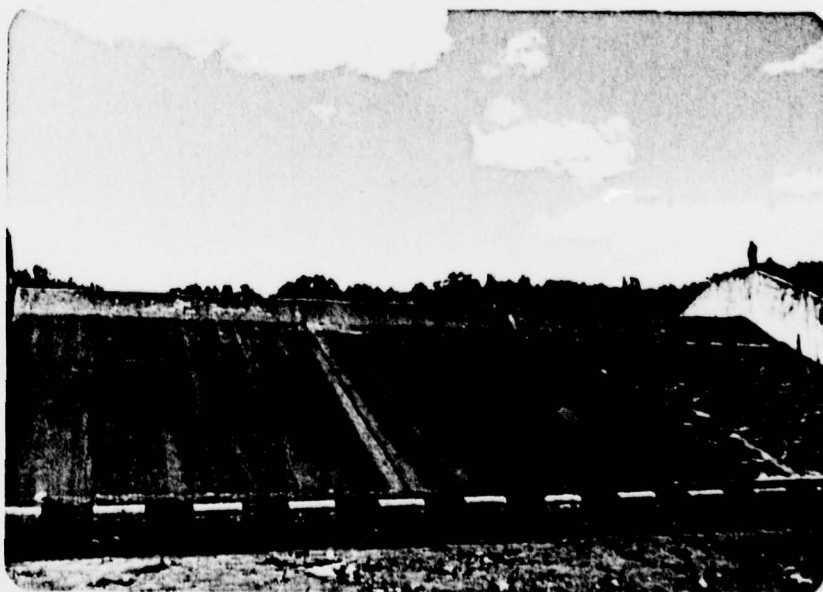
F. Spillway Chute and Stilling Basin.

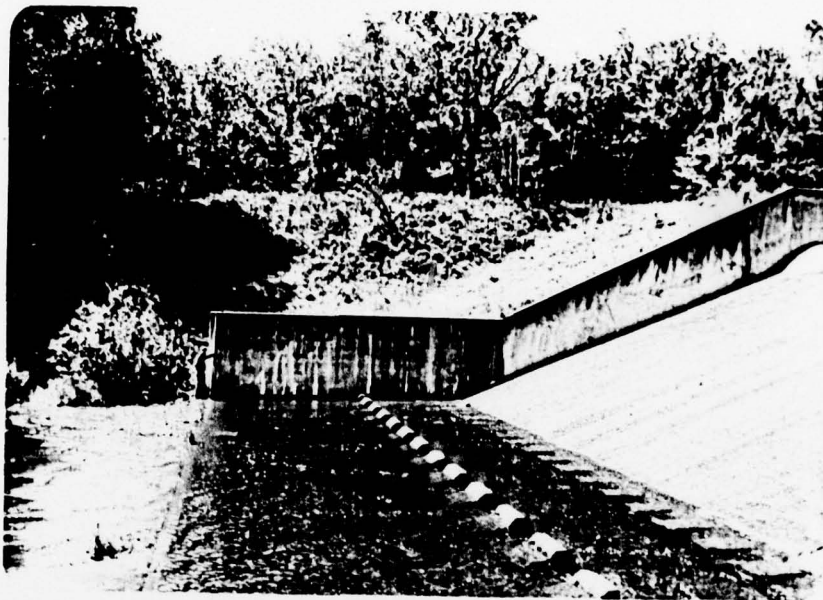
G. Stilling Basin and Right Abutment.

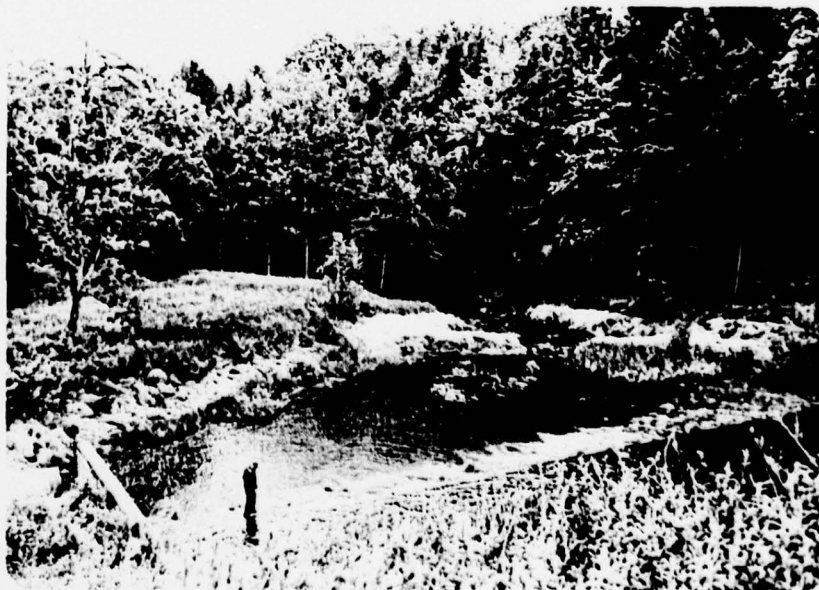
H. Area Downstream from Stilling Basin.

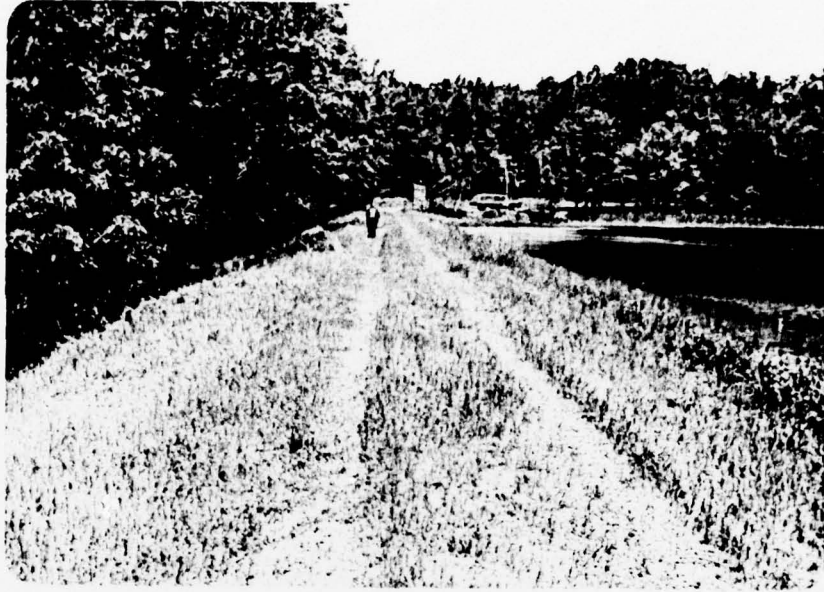
J. Pine View Dam - Located 1.3 Miles Upstream.

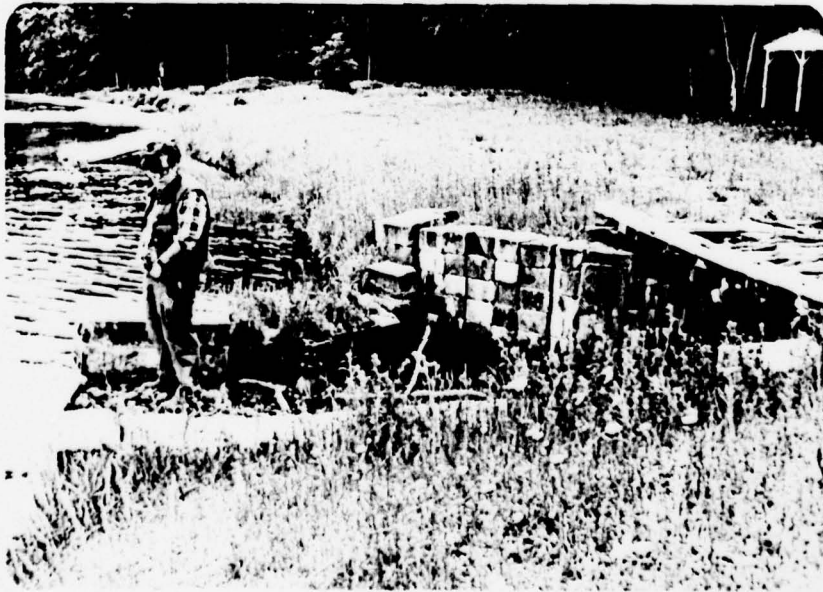
K. Spillway Structure at Pine View Dam.
